A Global Service for

All Brands of Engineered Mechanical Seal

Engineered Mechanical Seals Explained

Case Study – Oil & Gas Industry

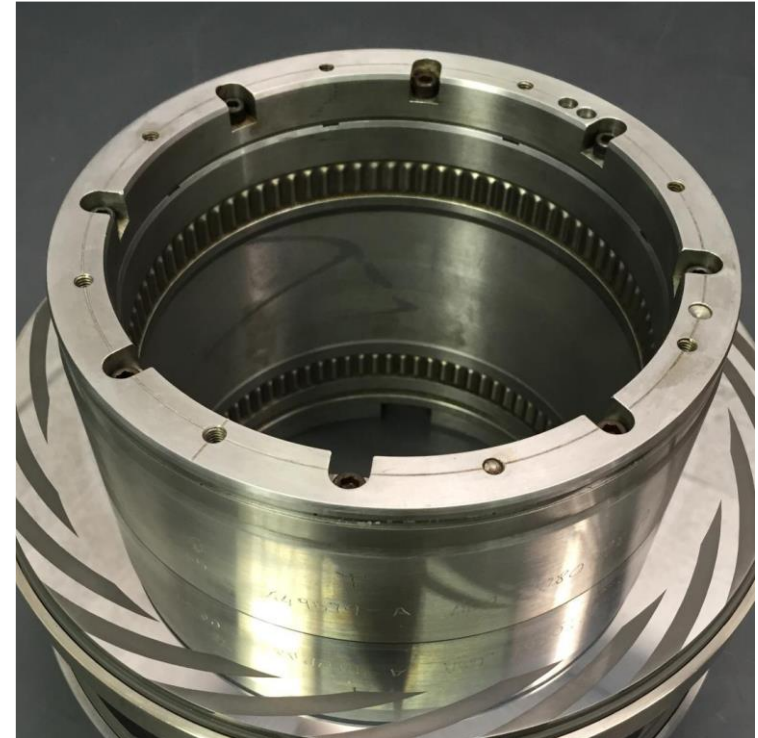
- ▶ Niche - top 5% of Mechanical Seals
- ▶ Utilised on High Dependency Pumps, Mixers, Dryers, Turbomachinery etc
- ▶ Normally $> 70\text{mm}$ Shaft Diameter
- ▶ Single Seals, Split Seals, Double Seals
- ▶ Wet and Gas Lubricated

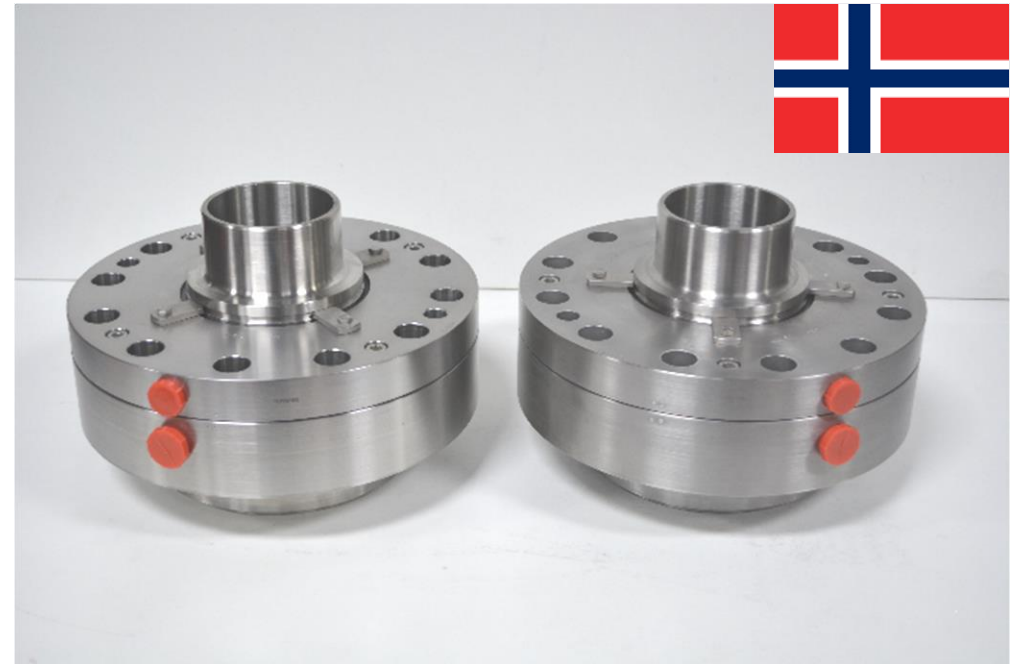
- ▶ Eagle Burgmann SHFV-D1/140-E2
- ▶ Sulzer Pump, Norway Offshore
- ▶ HC Condensate
- ▶ 3450rpm, 18 barg, 15°C
- ▶ Pump OEM looking for more responsive, economical support than via the OEM

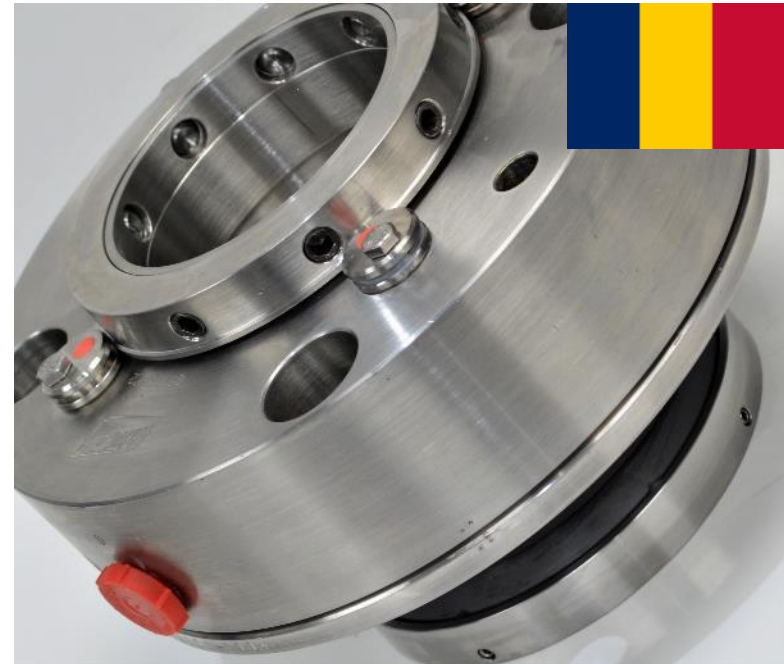
- ▶ John Crane T8610/100
- ▶ Sulzer DB DB34 8X8X11 Pump, Africa
- ▶ Produced Water
- ▶ 4850rpm, 208 barg, 80°C
- ▶ Pump OEM looking for more responsive, economical support than via the OEM

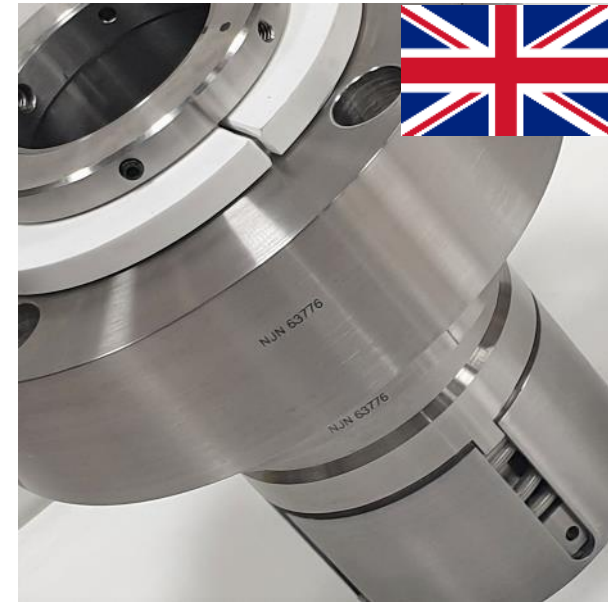
- ▶ Flowserve GU 3.437/3.250
- ▶ DB Bingham 6X10X14 LHCD Booster, UK Offshore
- ▶ Crude Oil
- ▶ 3650rpm, 9 barg, 48.9°C
- ▶ End user looking for more responsive service and technical support

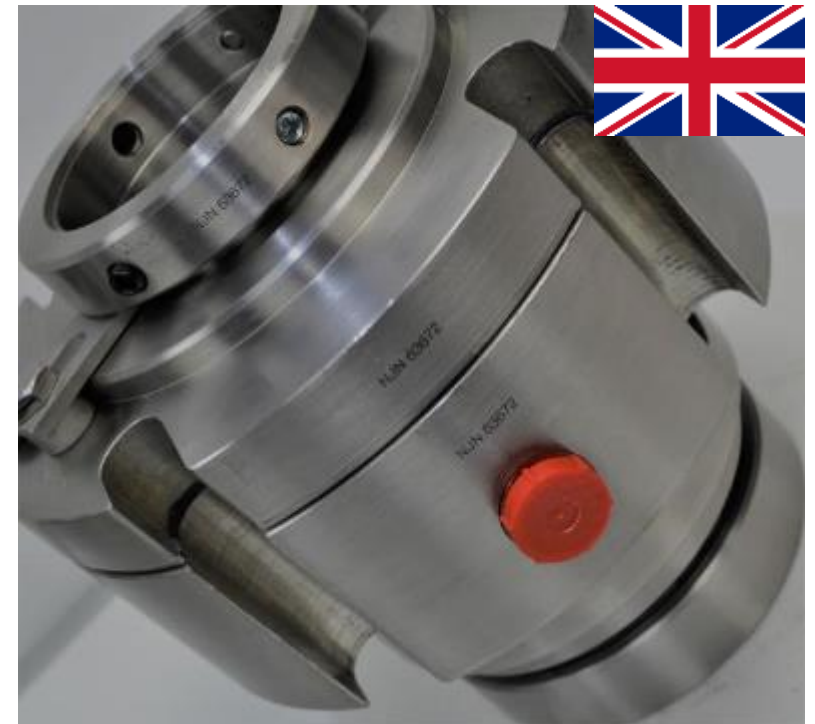
- ▶ Flowserve UHTW 4.250/4.437
- ▶ DB 4x6x10 1/2 C MSD, UK Offshore
- ▶ Crude Oil
- ▶ 6000rpm, 88.9 barg, 49°C
- ▶ End user looking for more responsive service and technical support

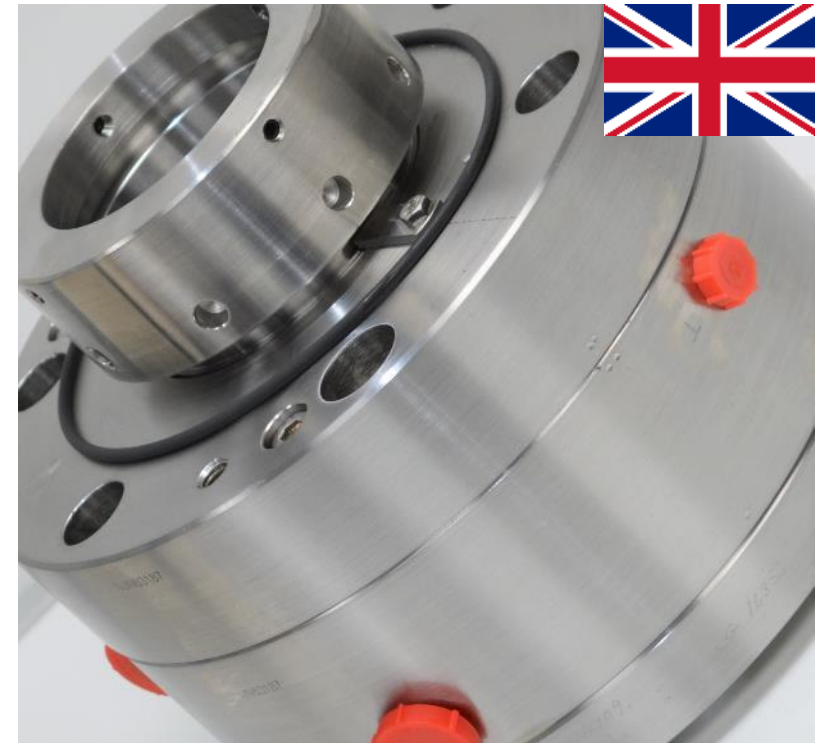
- ▶ John Crane (Flexibox) DRSP 0900
- ▶ Vertical Pump, UK Offshore
- ▶ HC Condensate
- ▶ 6000rpm, 90 barg
- ▶ End user looking for more responsive service and technical support

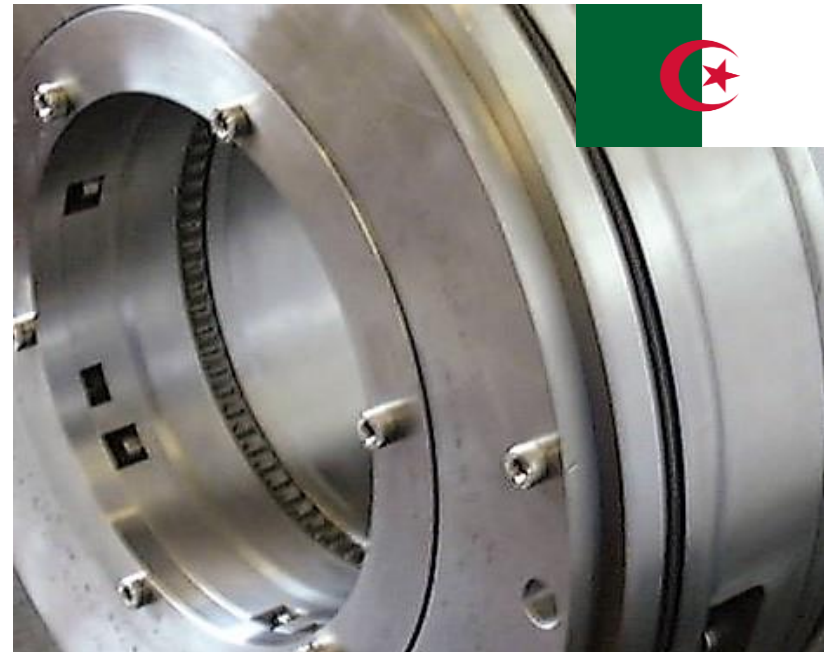
- ▶ John Crane T28AT/7.300" Dry Gas Seal
- ▶ Nuovo Pignone PCL603 Compressor, Algeria
- ▶ Natural Gas Pipeline
- ▶ 6,500rpm, 1070 psi, 58°C
- ▶ Provided alternative to OEM. Solution included comprehensive inspection and RCA, cost effective repair and recommendations to improve start up procedure to minimise oil migration through barrier seal and improve seal gas

filtration

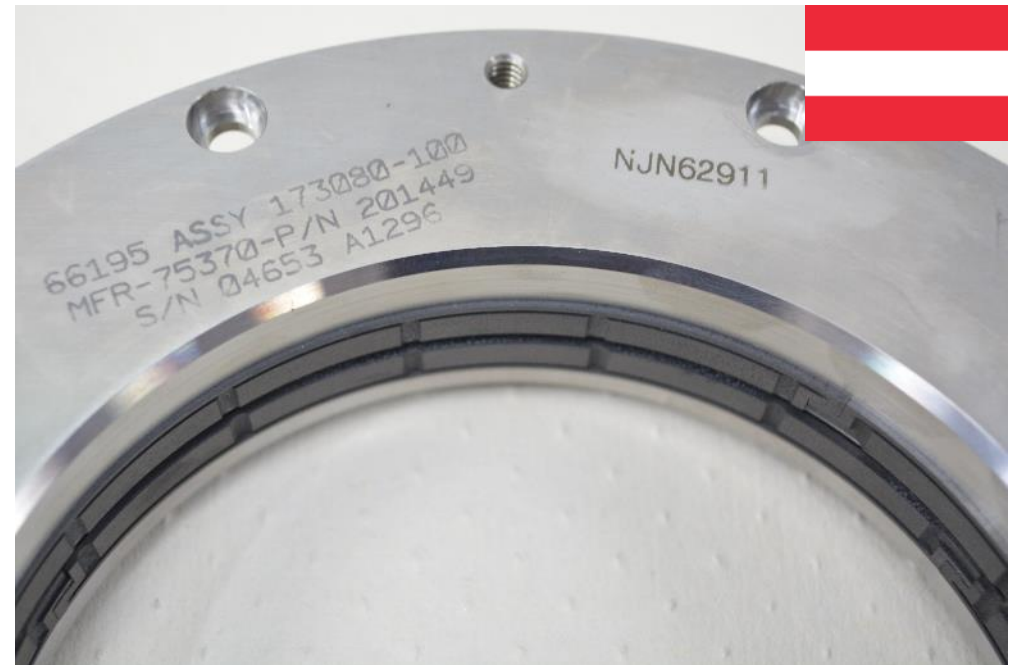
- ▶ Kaydon K-CBS/4.500"
- ▶ Solar C40 Compressor, Austria
- ▶ Gas Production & Storage
- ▶ 10,441rpm, N₂ @ 18 psi, 58°C
- ▶ One of 2 spare separation seals received for inspection and pressure test ahead of receiving a further 4 seals for repair

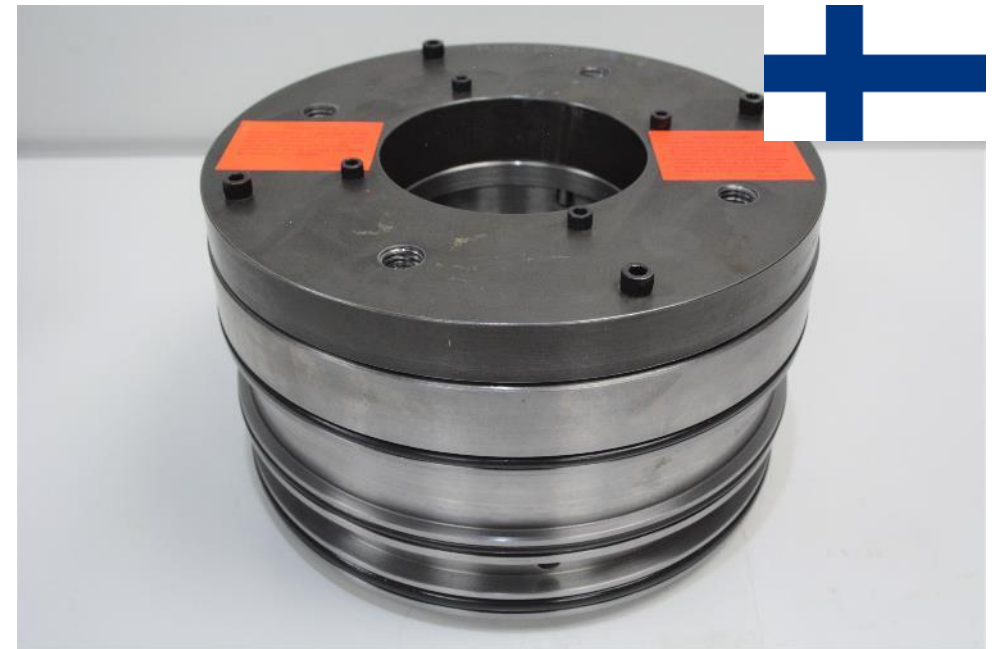
- ▶ Kaydon K-MOS/4.625" Oil Seal
- ▶ Stork Delaval (Siemens) Compressor, Finland
- ▶ Hydrogen Recycle
- ▶ 12,713 rpm max, 5.2 barg, 20°C
- ▶ One of 2 face and bushing oil seals repaired and dynamically tested for a refinery

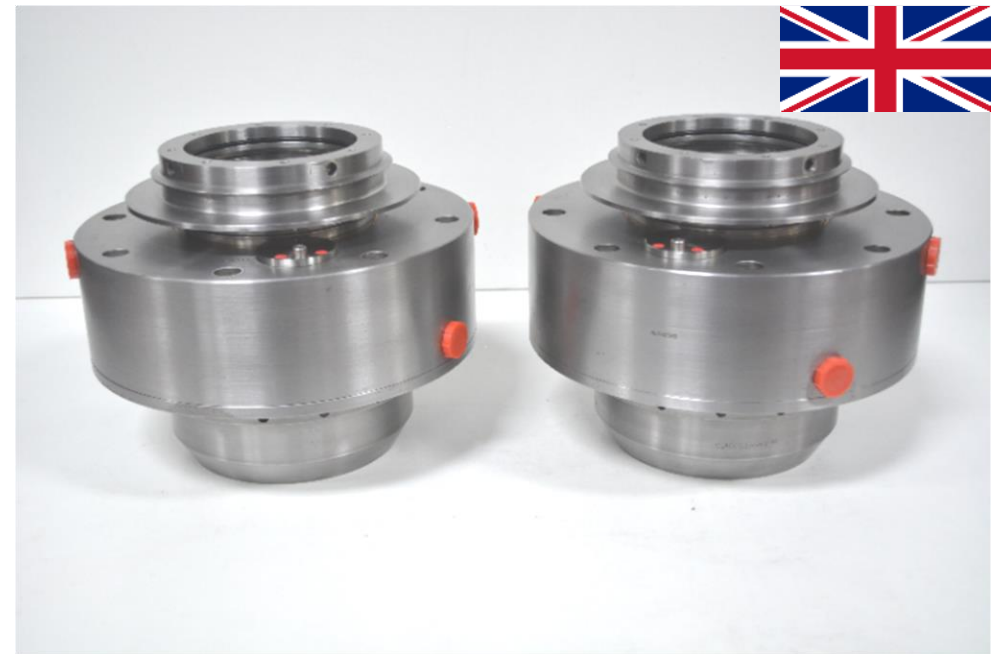
- ▶ John Crane RRSP/1450
- ▶ Sulzer HPT-300-630 Pump, UK Power Plant
- ▶ Boiler Feed Water
- ▶ 3000rpm, 12.5 barg, 160 to 175°C
- ▶ NASH inspection/assessment confirmed premature failure caused by previous repairer fitting solid PTFE o rings rather than peroxide cured EP

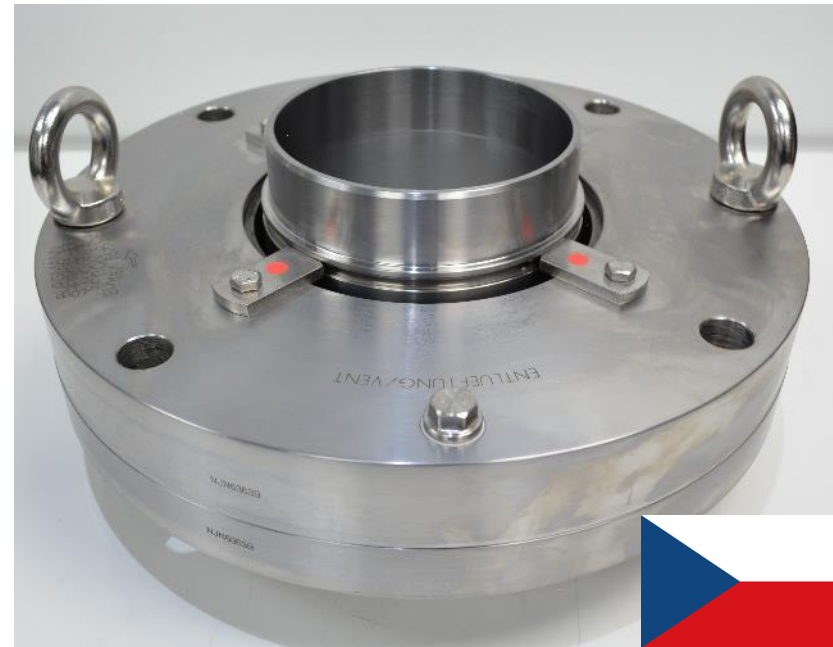
- ▶ Burgmann SHF11-E3/135mm
- ▶ CEZ Power Plant
- ▶ Boiler Feed Water
- ▶ 4670rpm, 1.43 MPa, 175°C
- ▶ NASH provided a more responsive, cost effective repair than the seal OEM

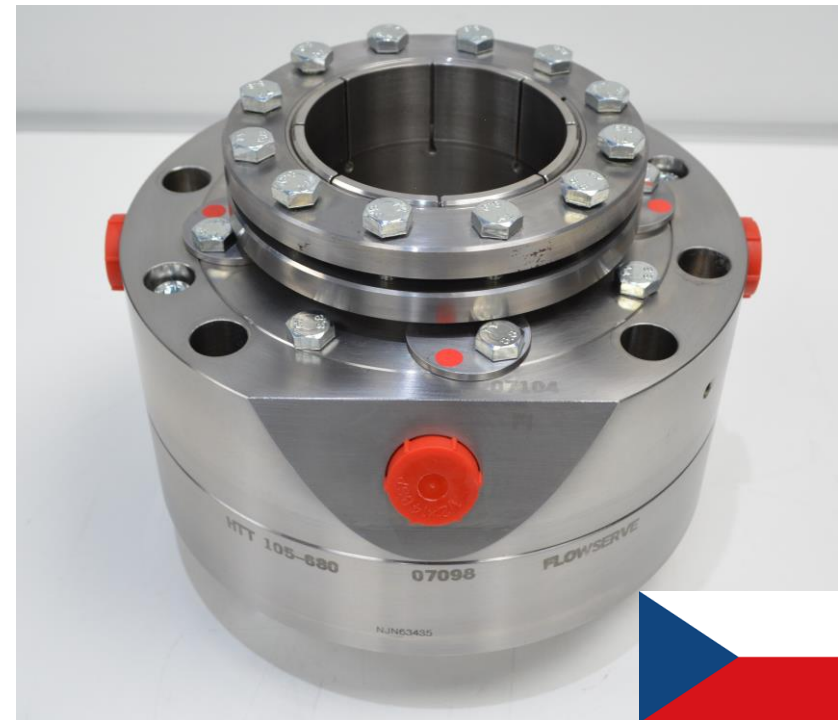
- ▶ Flowserve HTT/83mm
- ▶ CEZ Power Plant
- ▶ Boiler Feed Water
- ▶ 1480rpm, 2.5 MPa, 120°C
- ▶ NASH provided a more responsive, cost-effective repair than the seal OEM

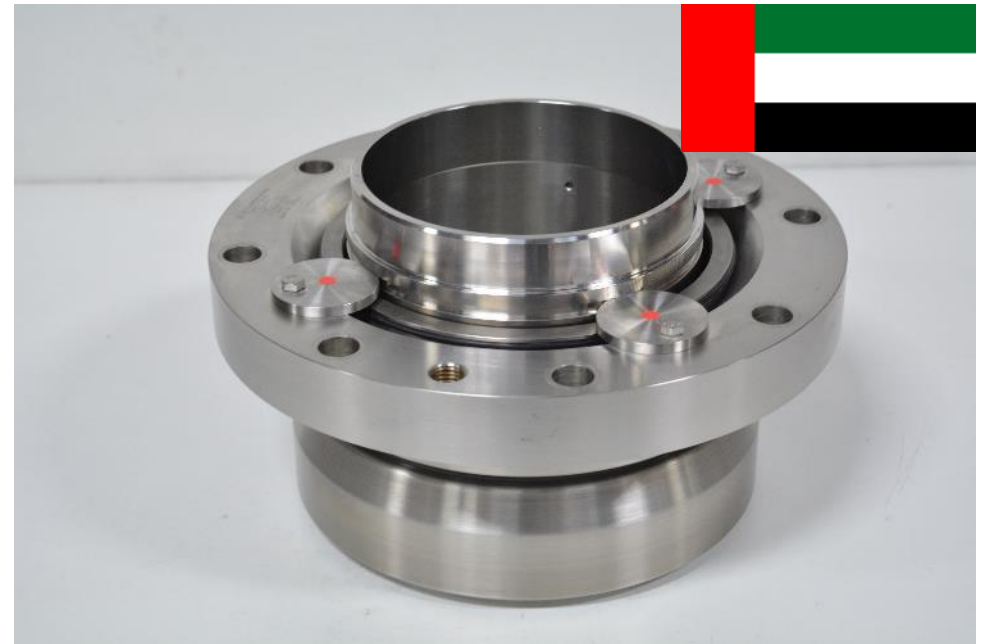
- ▶ EagleBurgmann SAPI1/155mm
- ▶ Torishima MHB/3WX Pump, UAE
- ▶ Boiler Feed Water
- ▶ 5480rpm, 28.8 barg, 80°C
- ▶ One of a pair of seals repaired for a power plant in Saudi Arabia via our partner in the UAE. NASH was able to provide significantly reduced cost of repair compared to the seal OEM

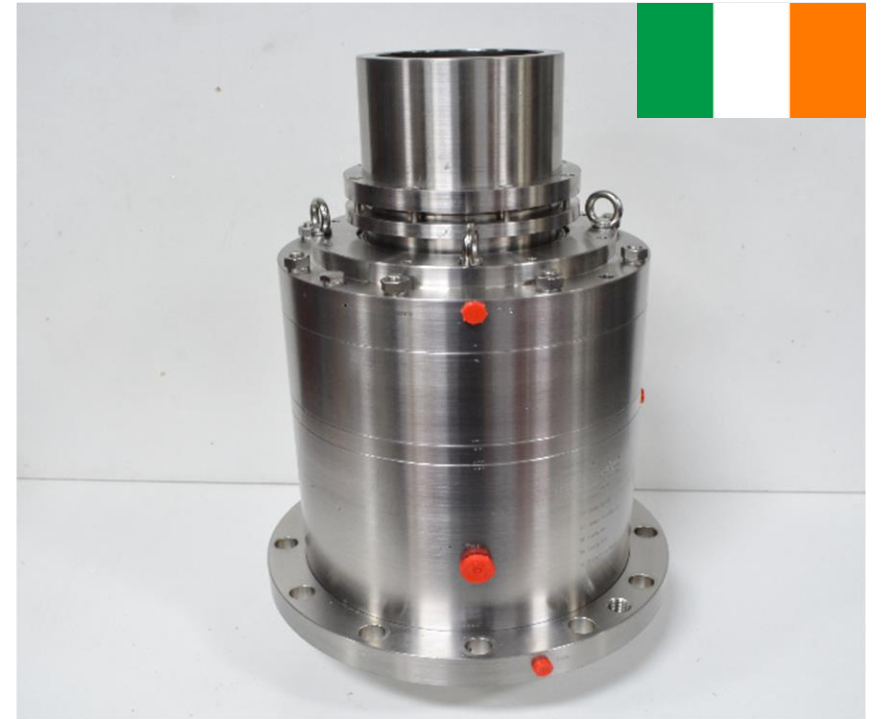
- ▶ Flowserve Mixerpac 2552/125
- ▶ Comber Filter Dryer, Republic of Ireland
- ▶ Lercanidipine
- ▶ 1 to 15 rpm, 15 – 70°C, -1 to 2 barg, 4 barg N2 barrier gas
- ▶ Seals repaired and rotary faces upgraded to a carbon grade specifically designed for dry nitrogen applications. Average seal life increased from 9 months to 3 years

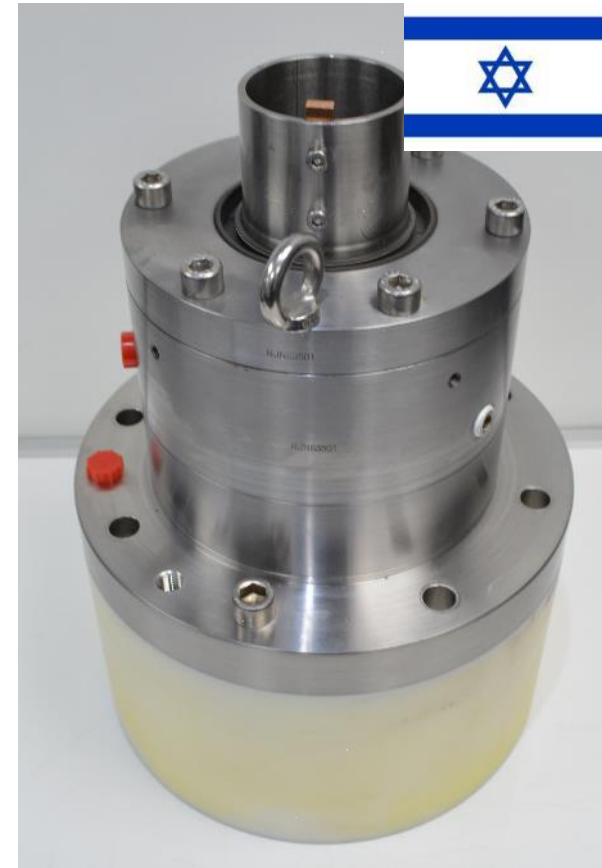
- ▶ John Crane 5282GD/60mm, Gas Lubricated
- ▶ GL Filter Dryer, Israel
- ▶ Pharmaceuticals
- ▶ 5 to 25 rpm, 15 – 70°C, -1 to 4 barg, 6 barg N2 barrier
- ▶ Seals were being repaired locally, but regularly failed within months. Working with NASH, MTBF is now +3 yrs. We recently introduced a service exchange unit at NASH to minimise process down time

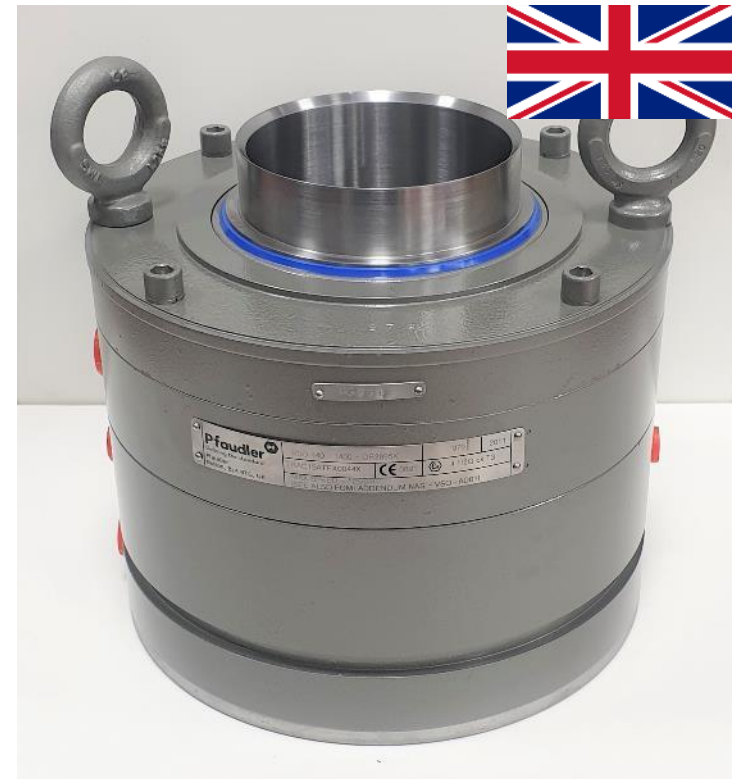
- ▶ Pfaudler Double Seal Cartridge 140mm
- ▶ Pfaudler VSO Glass Lined Reactor, Scotland
- ▶ Pharmaceuticals
- ▶ 90 rpm, 100°C, 3 barg, 5 barg barrier
- ▶ NASH provides Pfaudler UK with an exclusive aftermarket repair service for their entire range of vessel seals. This service is also available to end users through all our partners in EMEA

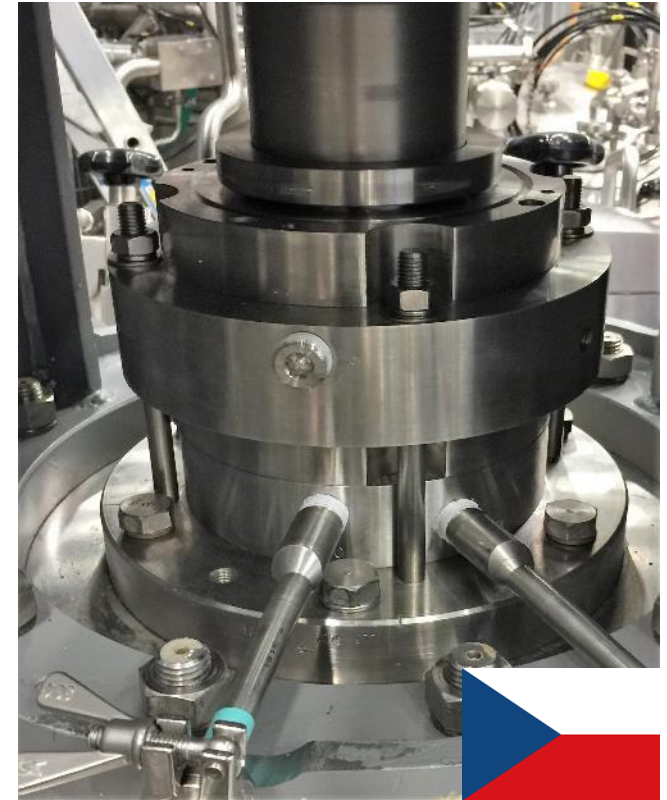
- ▶ John Crane T7700/90mm, Gas Lubricated
- ▶ Stainless Steel Vessel, CZ
- ▶ Pharmaceuticals
- ▶ 80 rpm, 130°C, 3 barg, 4 barg N2 barrier
- ▶ Seals were originally liquid lubricated and being repaired in house, but regularly failed within months. Working with NASH, seal was converted to gas lubricated configuration and MTBF is now +3 yrs.

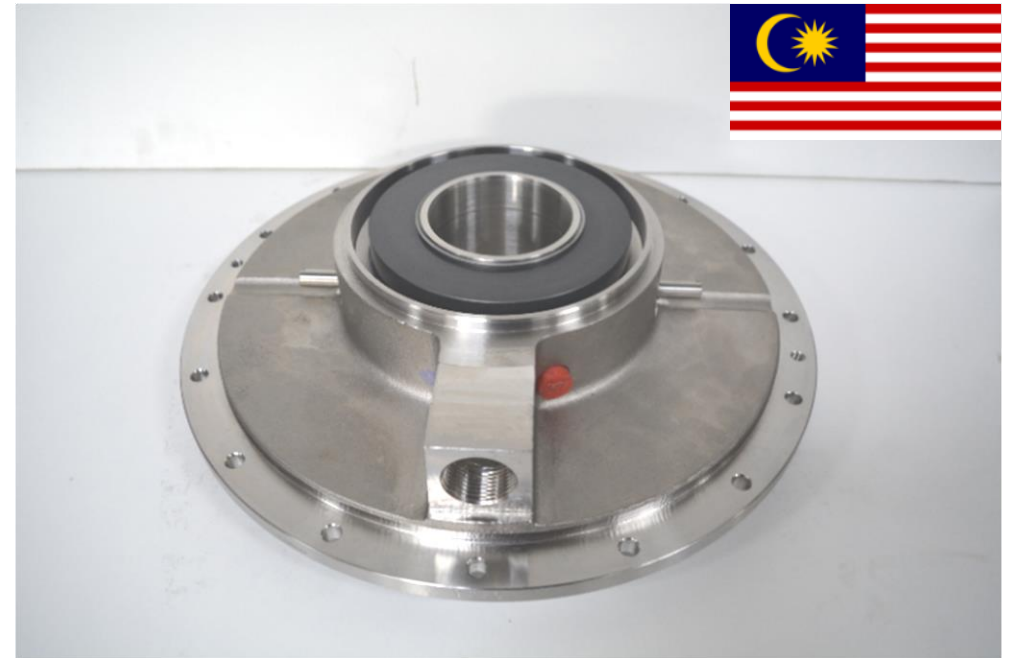
- ▶ Netzsch GRD/80
- ▶ Netzsch LME 60 Bead Mill, Malaysia
- ▶ Offset Ink
- ▶ 360 to 710rpm, 90°C, 0.9 to 1.5 barg
- ▶ NASH partner arranged for seal to be sent to NASH after x3 premature failures. Seal inspection confirmed reverse pressure caused by cleaning process

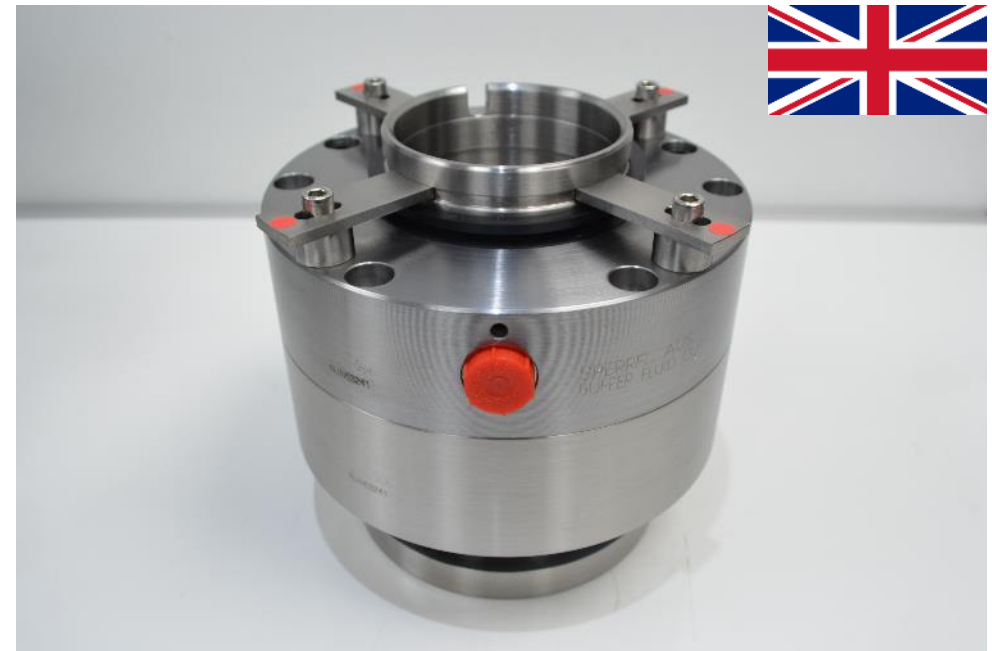
- ▶ Burgmann MR1S1F/24/90mm
- ▶ Drais DCP 170 Bead Mill, UK
- ▶ Heavy Pigmented Solvent Based Paint
- ▶ 350 to 750rpm, 60°C, 2 barg, Glycol Barrier @ 6 barg
- ▶ One of many cartridge units successfully repaired over the past 25 yrs for a global paint company producing paint for car manufacturers

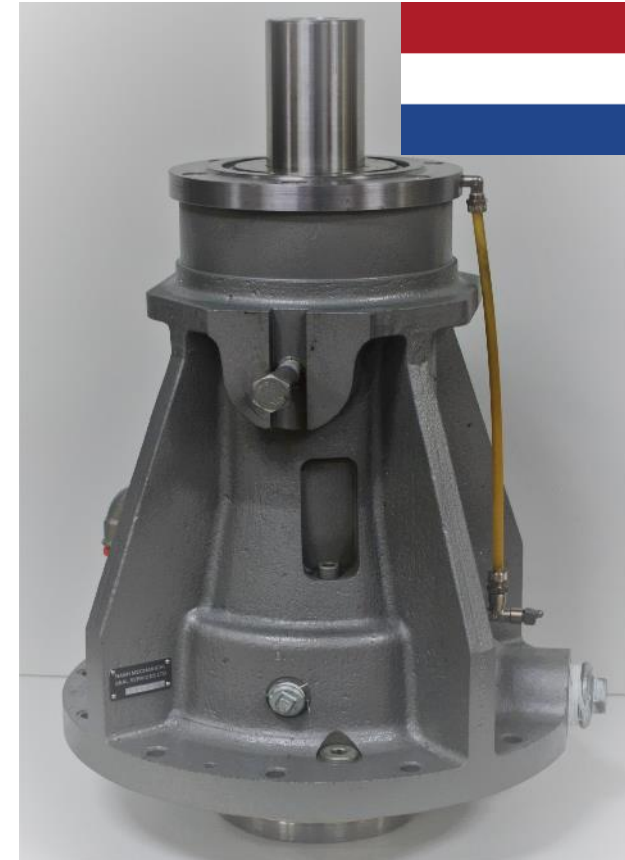
- ▶ Buhler Seal & Bearing Cartridge/100mm
- ▶ Buhler Cobra Bead Mill, Netherlands
- ▶ Serptane PW 25-28H Ink
- ▶ 487rpm, 110°C, 3 barg, Glycol Barrier @ 6 barg
- ▶ One of many Buhler Cobra Seal & Bearing Cartridges repaired for a European ink manufacturer that could not obtain good prices and service from the OEM

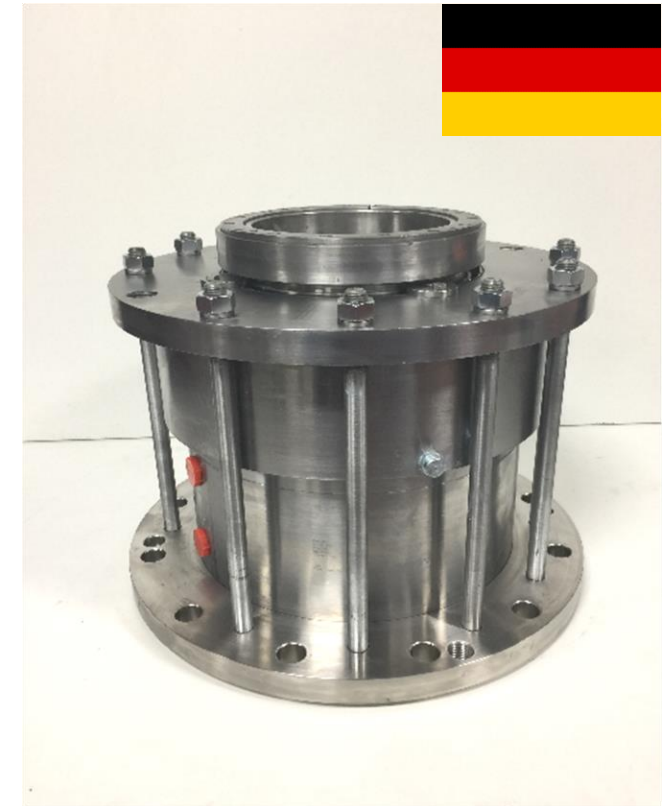
- ▶ Flowserve 2564/180mm
- ▶ Alloy Mixer, Leverkusen, Germany
- ▶ Additive for Paper Manufacture
- ▶ 60rpm, 120°C, 2 barg, Water Glycol Barrier
- ▶ User unhappy with poor service and high prices from the seal OEM. NASH partner arranged for seal to be sent to NASH in the UK for repair with spares kit also supplied

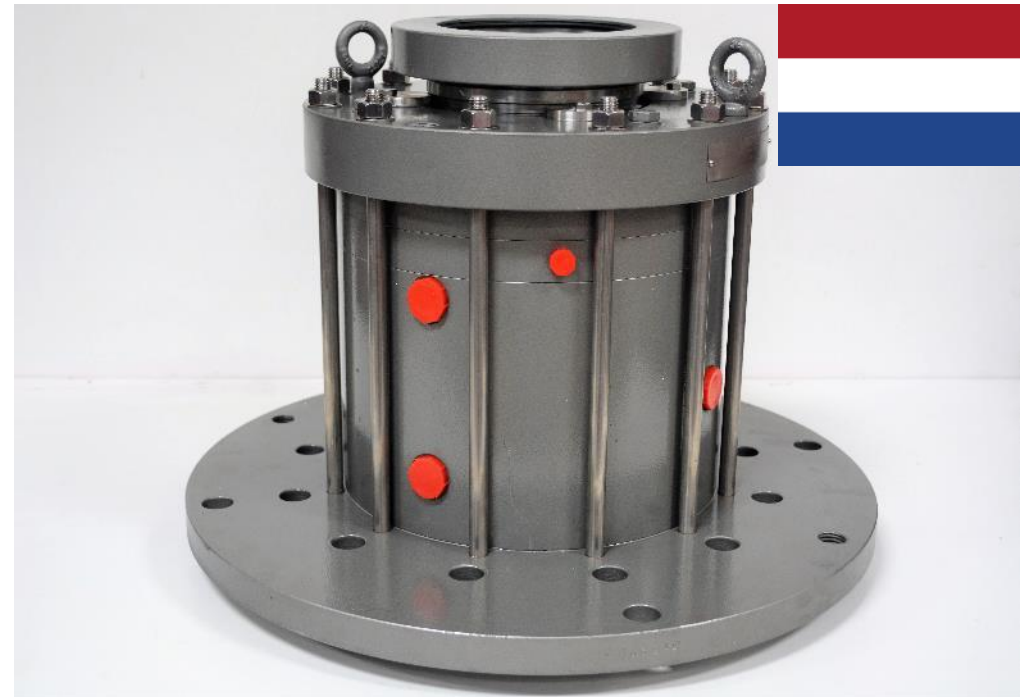
- ▶ De Dietrich MDL140mm
- ▶ De Dietrich Reactor, Netherlands
- ▶ Styrene & Pentane
- ▶ 85 rpm, 130°C, 10.5 barg, Oil Barrier @ 11.5 barg
- ▶ Seals were being repaired by the OEM, but lead times were up to 16 wks. Working via our partner in the Netherlands, we reduced average lead times to 3-4 wks and we are helping to improve MTBF

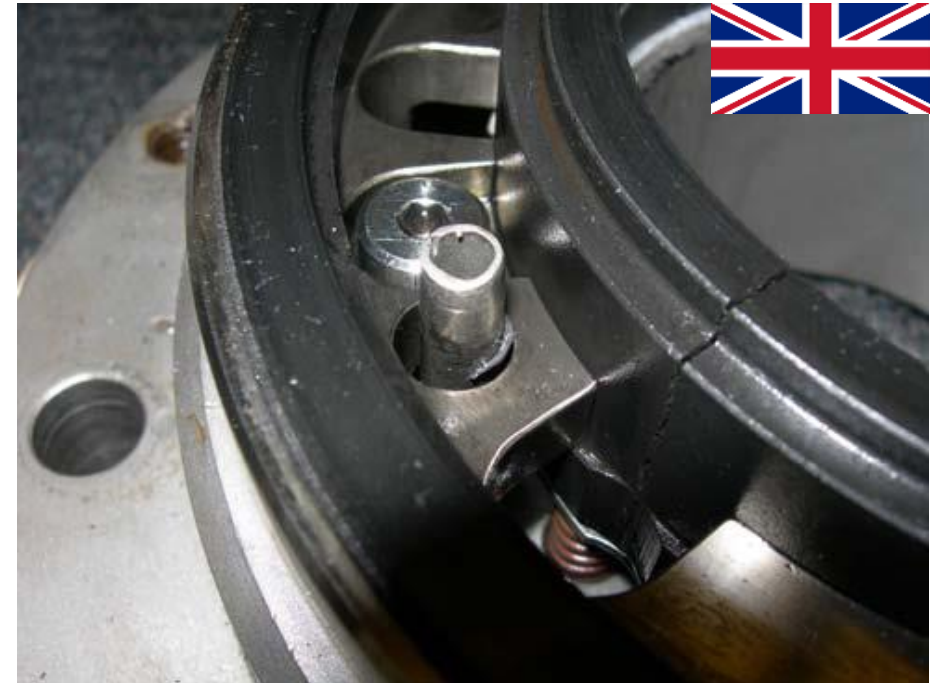
- ▶ John Crane T151/3.500"
- ▶ Alloy Mixer, United Kingdom
- ▶ Methyl Methacrylate
- ▶ 115rpm, 100°C, 2.5 barg, Glycerol Triacetate @ 3.5barg
- ▶ User unhappy with poor quality repairs from seal OEM leading to premature failures – incorrect o ring material and inboard wedge dimensionally incorrect causing stationary seal ring to crack

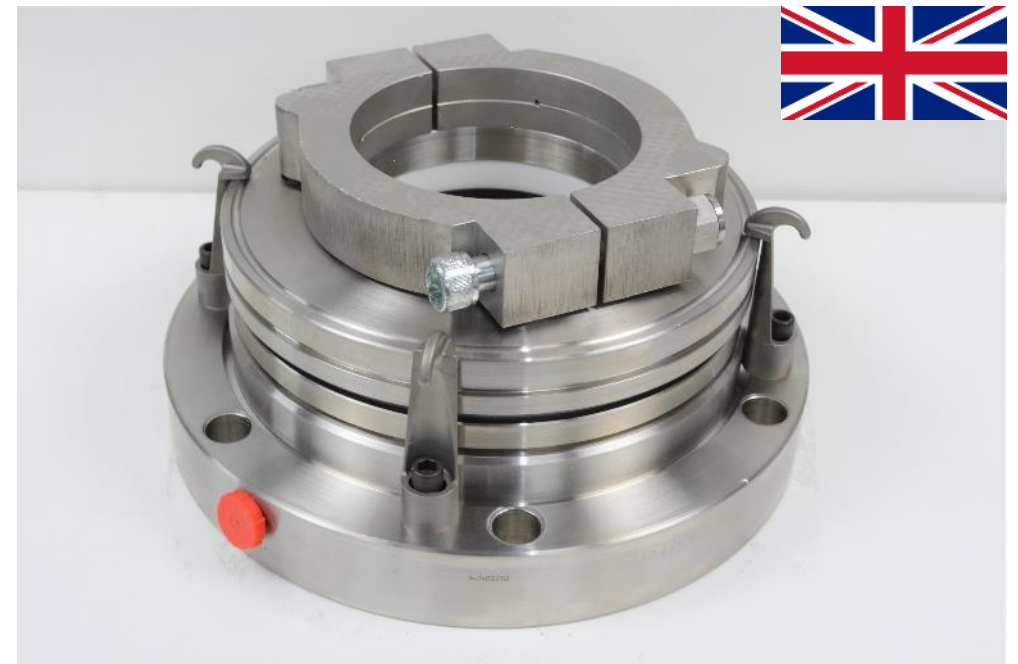
- ▶ John Crane T151/140mm
- ▶ Alloy Mixer, Scotland
- ▶ Agrochemicals
- ▶ 90rpm, 100°C, 2 barg, Mineral Oil @ 4 barg
- ▶ One of many engineered seals repaired via one of our OEM Mixer partners for a global agrochemicals manufacturer

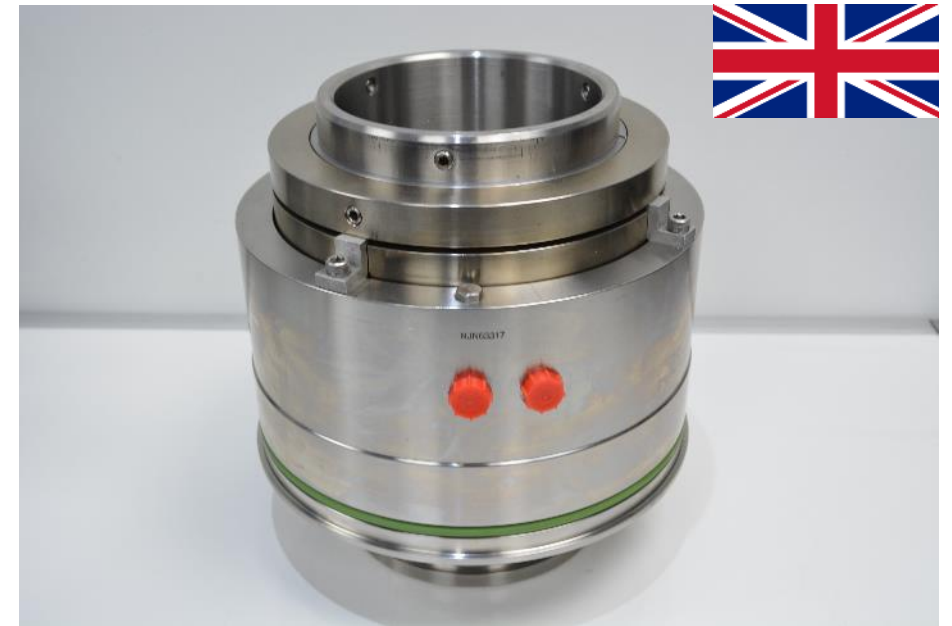
- ▶ Safematic SAB/140mm
- ▶ Vertical Pulper, Scotland
- ▶ Paper Pulp
- ▶ 280rpm, 50°C, 2 barg, Water Barrier
- ▶ Spare seal sent to NASH first for inspection and pressure test as had been on shelf for 5+ yrs. Used seal also subsequently repaired and returned to site stores

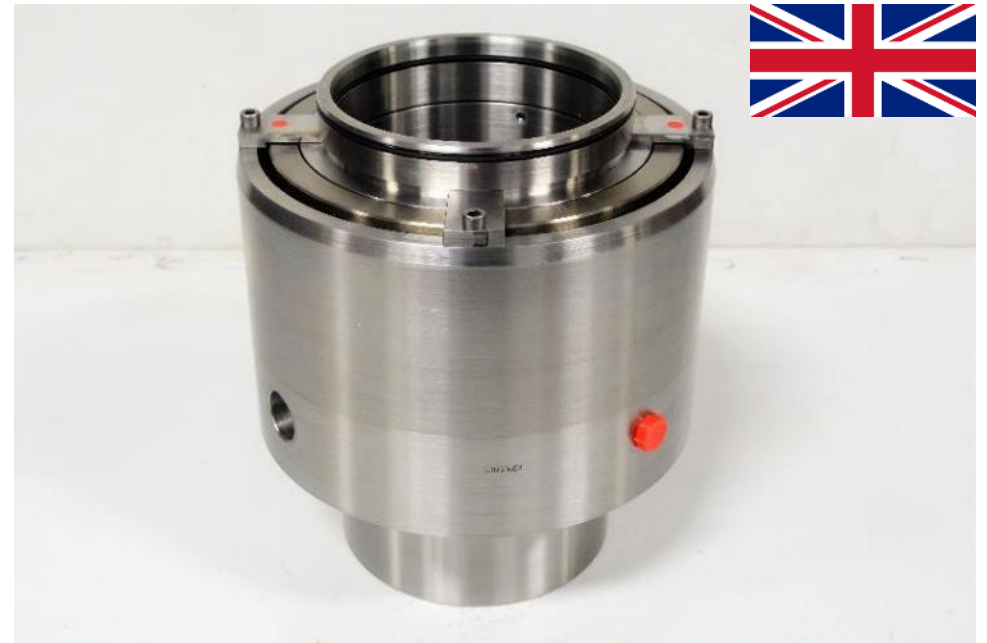
- ▶ EagleBurgmann LP-D/135mm
- ▶ Sunds Difibrator Refiner, UK
- ▶ Pulp for Board
- ▶ Water Barrier
- ▶ One of many seal cartridges of this type refurbished for a UK board manufacturer
